FACE INVESTIGATION

SUBJECT: FARMER DIES WHEN PINNED BETWEEN ARM AND FRAME OF A SKID STEER LOADER

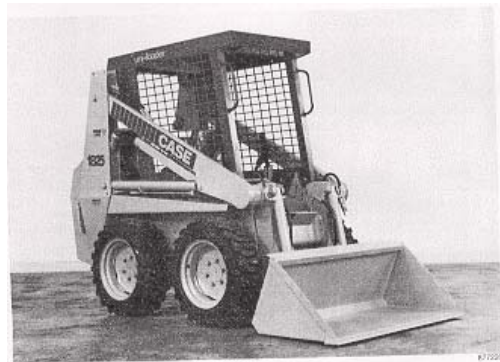
Figure 1. View of Skidsteer Loader from Operator's Manual
